**APPENDIX G-4**  
**Limited Environmental Assessment and Recommended**  
**Action Plan**

November 10, 2006  
Project No. 71867/001

**Subject: Results of Limited Environmental  
Assessment and Recommended Action Plan**

**Project: Peaceful Valley Ranch  
Jamul, California**

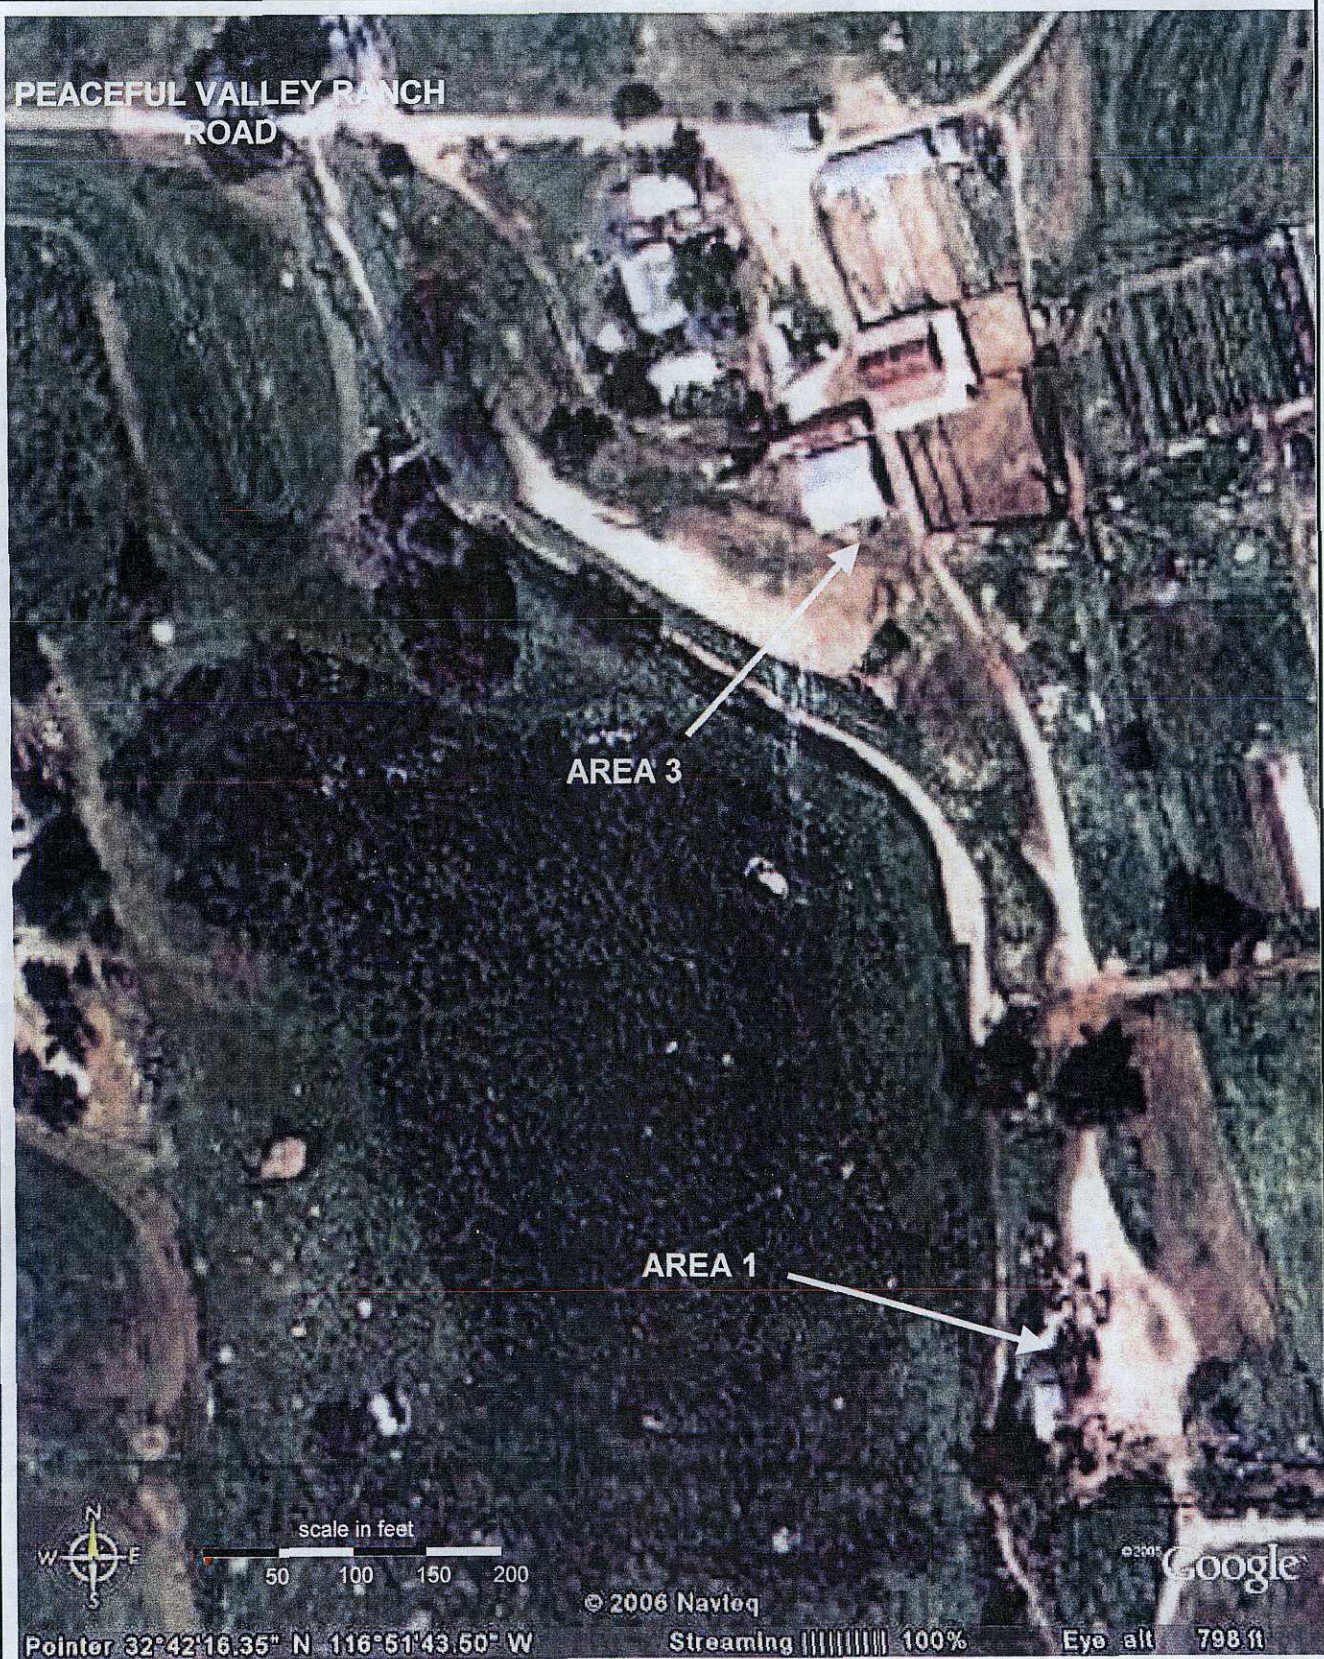
**2**

On August 3, 2006, Kleinfelder and Soclaris Contractors (Soclaris) performed limited excavation in front of the maintenance/work shop in Area 3 in the vicinity of the two protruding pipes thought to be a fill pipe and a dispensing pipe. Soclaris, under Kleinfelder's supervision, trenched in this area to a depth of approximately 4 feet below ground surface (bgs) (Figures 2 and 3).

## SITE PLAN

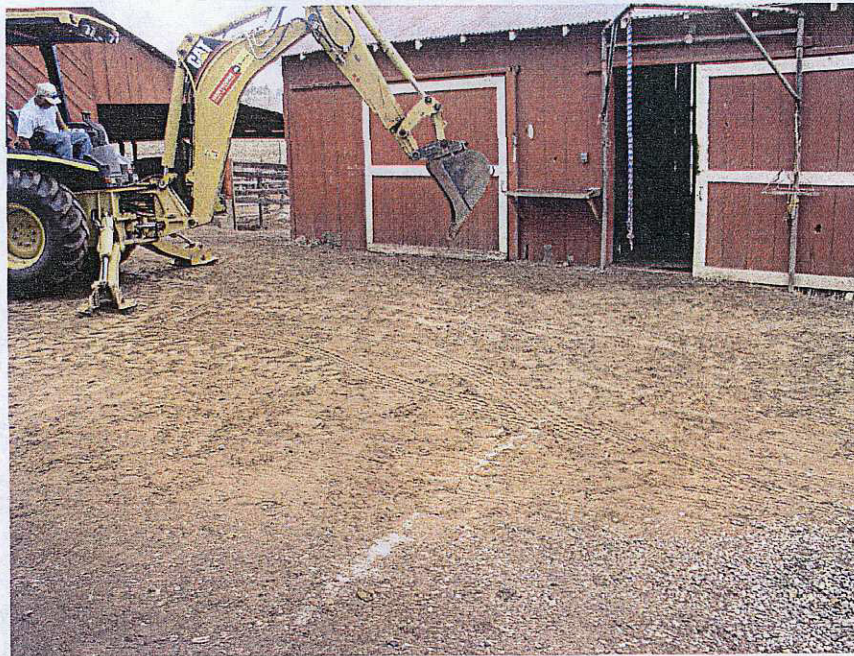
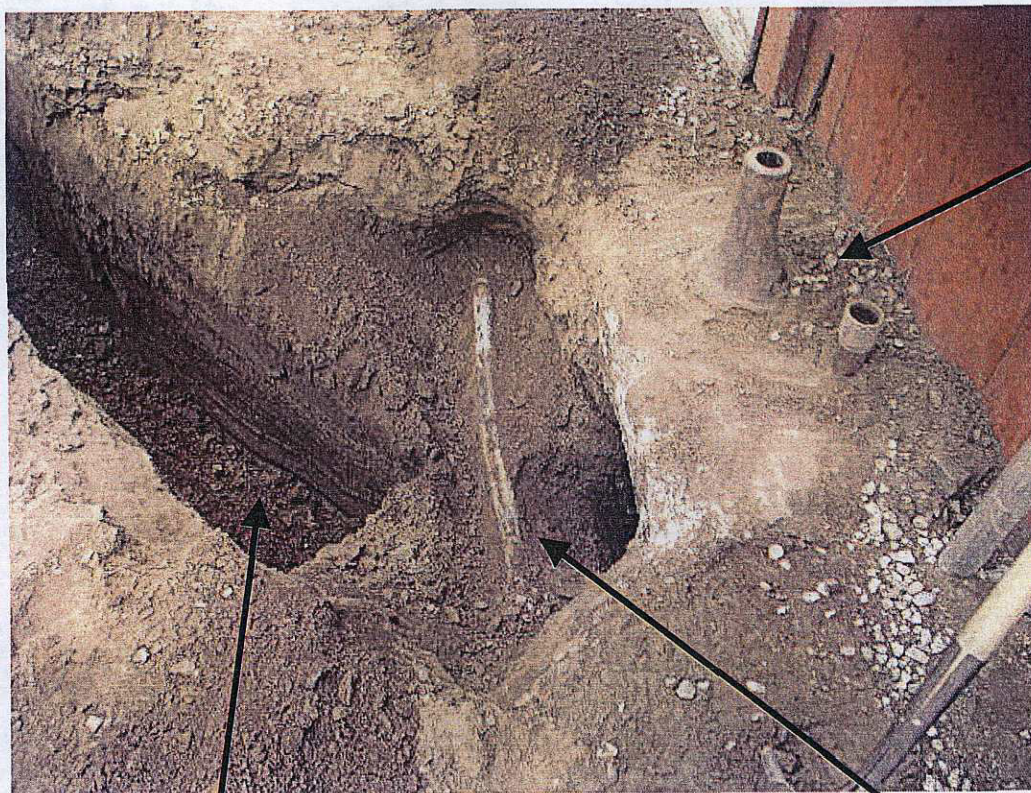
**3A**

# Excavation for UST in Area 3

TRENCH  
(TO APPROX. 4 FT BGS)

UTILITY LINE

Kleinfelder and Dr. Sionit agreed that further efforts to locate the UST will be postponed until the maintenance/work shop structure is demolished, since it is possible that the UST, if present, is beneath the footprint of the structure.

Other than the presence of the protruding pipes, evidence of a UST in Area 3 was not found during the investigations in the area in front of the maintenance/work shop. Kleinfelder recommends that additional investigation be conducted beneath the maintenance/work shop after the structure is demolished. If a UST is found, it is recommended that it be removed under the supervision of an environmental professional and that confirmation samples be collected from the bottom and sidewalls of the excavations and analyzed for TPH-Ext.

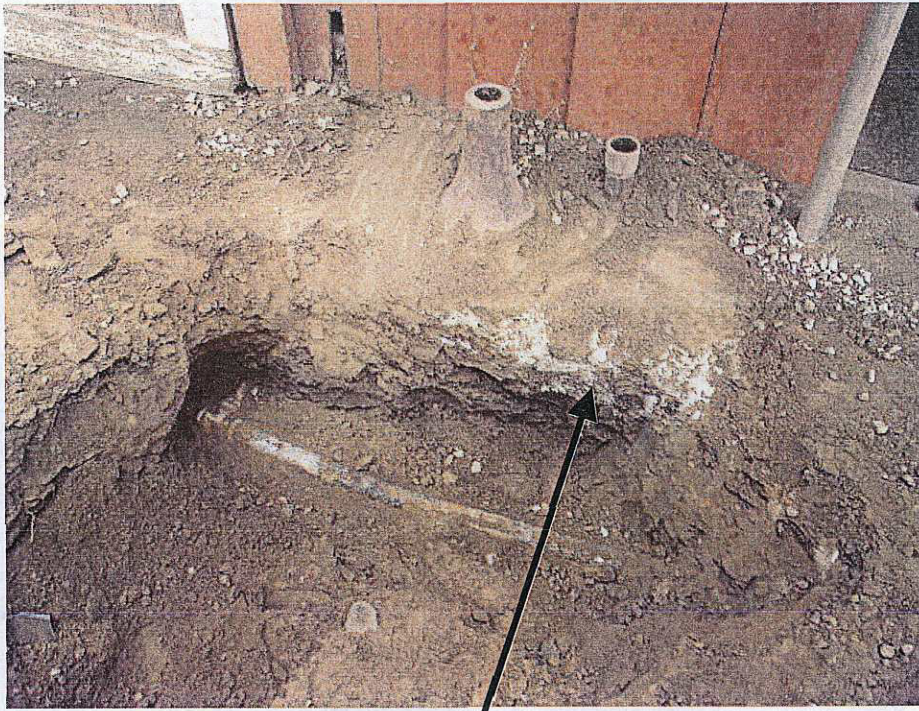
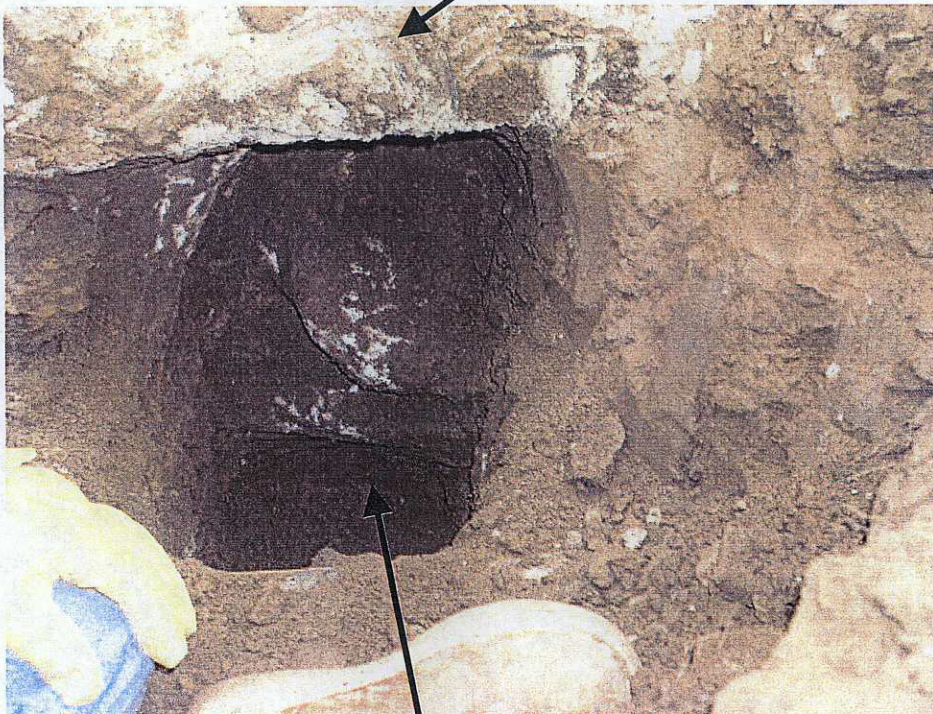
**3B**

No visible evidence of a UST was observed during the excavation activities. Directly around the two protruding pipes, beneath a thin veneer of soil cover, Kleinfelder observed an approximately 1-foot thick layer of concrete. The apparent fill pipe and dispenser pipe were encased in more concrete (to a depth of approximately 2 feet bgs) beneath the 1-foot thick concrete layer and a discontinuous layer of soil that was a few inches thick. No indications of a UST were present. A shovel was used to hand-excavate from the bottom edge of this concrete laterally toward the building, to assess whether the two pipes extended beneath the bottom of the concrete. Kleinfelder found that the pipes did not extend below the bottom of the concrete. The excavation was backfilled with the native soil.

### Excavation for UST in Area 3

CONCRETE LAYER

AREA BENEATH CONCRETE LAYER

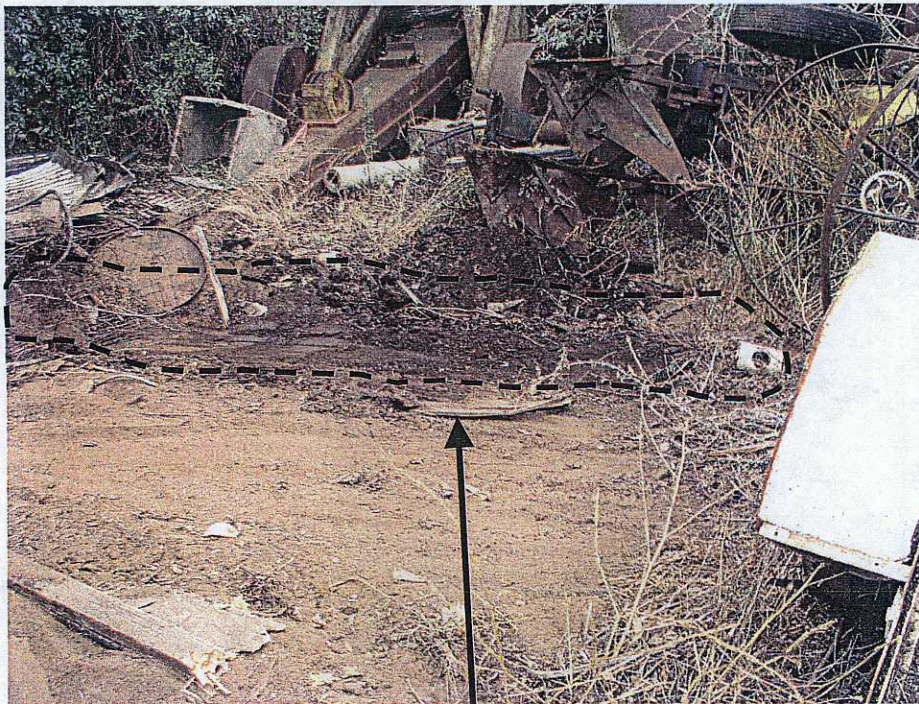
**3C**

Kleinfelder and Soclaris initially moved aside large equipment and vehicles in Area 1 on August 3, 2006 and Kleinfelder observed the surface soil staining beneath these objects, which were discussed in the RBF Phase I ESA. Kleinfelder identified two smaller stained areas as potentially impacted areas. The first area (referred to herein as Area A) was beneath the area of the northern-most truck where the engine had been located. The second area (Area B) was beneath machinery south of Area A. The soil here in Area B was much darker than the surrounding soil, and appeared to be burn/ash. Photographs of these two areas are shown in Figure 3.

Based on the results of the soil sample analyses, it appears that the stained soil in Area A is not impacted by any of the compounds for which analyses were performed.

The stained soil in Area B appears to be impacted by petroleum hydrocarbons and lead. On October 17 and November 8, 2006, Kleinfelder conducted a visual assessment of the stained area using a hand auger to estimate the lateral and vertical extent of impacted soil. Based on this assessment, Kleinfelder estimates the extent of impacted soil to be approximately 6 feet by 7 feet to a depth of 2 feet.

### Staining in Area 1

AREA A

AREA B

Kleinfelder recommends that the impacted soil in Area B and any surrounding stained soil be excavated to a depth of approximately 2 feet bgs or to the bottom of visible staining prior to the property development activities. Based on the field observations and earlier assessments, the area of impacted soil is approximately 6 feet by 7 feet in Area B. The excavated soil should be placed in 55-gallon drums or other appropriate container and characterized for offsite disposal. Characterization of the excavated soil should include analyses for TPH-Ext and lead. Confirmatory sample should be collected from the bottom of the excavation and analyzed for lead and TPH-Ext.

As a precautionary measure, Kleinfelder also recommends that the soil in Area A be excavated to the extent of the visible staining. The excavated soil should be placed in 55-gallon drums or other appropriate container and characterized for disposal.

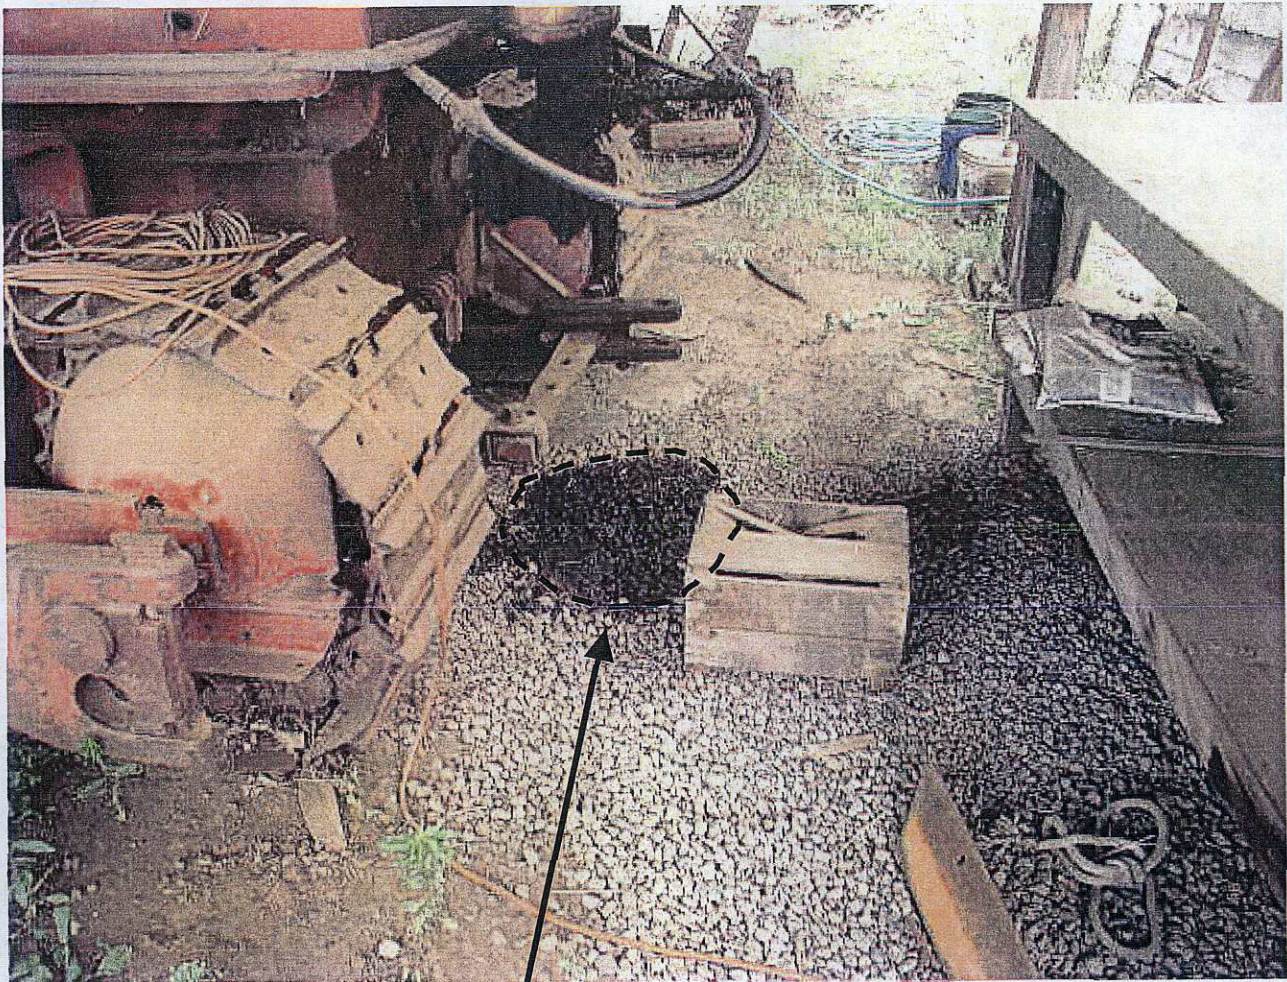
**3D**

On October 17, 2006, Kleinfelder used a hand auger to explore subsurface soils beneath an area of staining to visually estimate the depth of impact. The staining is approximately located beneath the former location of a tractor, which was moved by the Owner in order to assess this area. Based on the color and odor of the soil, Kleinfelder estimates that impacted soil in this area extends to a depth of approximately 2 feet bgs. The lateral extent appeared to be approximately 4 feet in diameter.

Staining in Area 3

APPROXIMATE  
EXTENT OF LATERAL  
IMPACT

Kleinfelder recommends that the stained soil in Area 3 be excavated prior to the Site development. Based on Kleinfelder's field observations and the observations in the RBF Phase I ESA, the excavated area should have dimensions of approximately 6 feet by 6 feet and a depth of approximately 3 feet. The excavated soil should be placed in 55-gallon drums and characterized for offsite disposal.

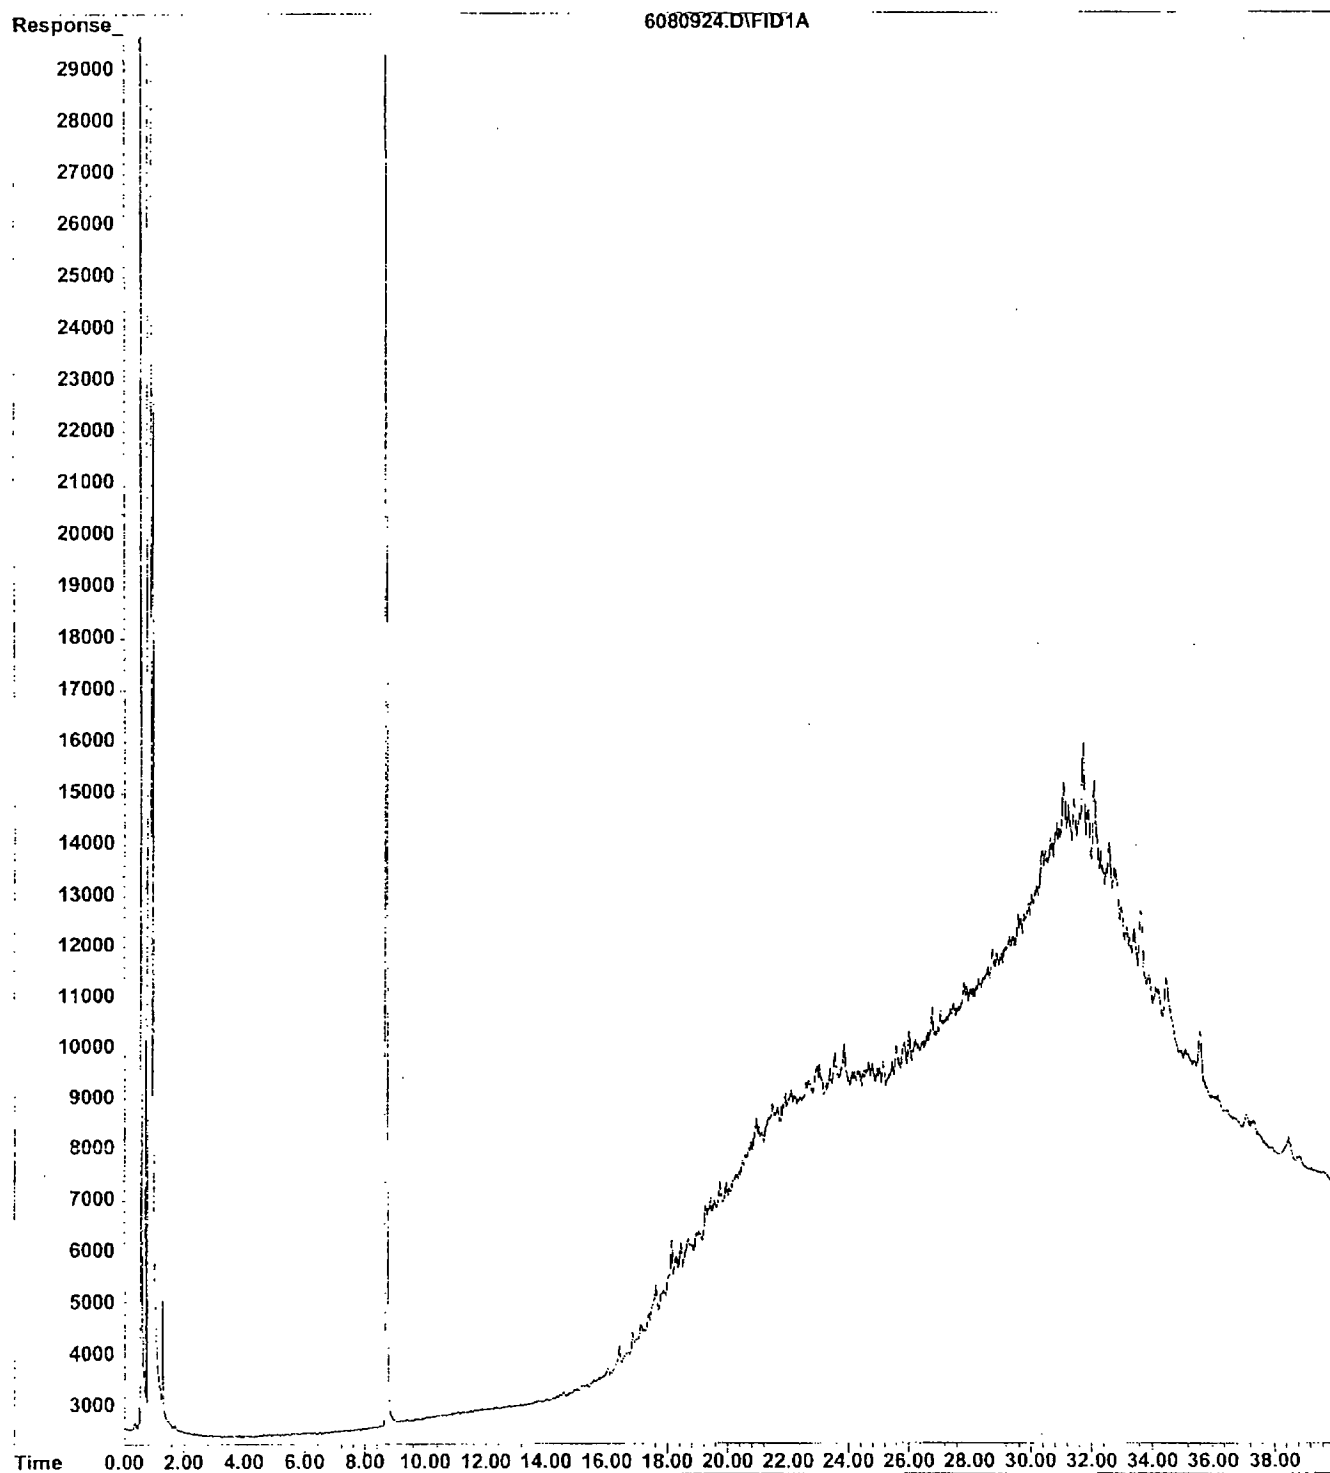
TPH as gasoline (carbon range C6 to C10) and TPH as diesel (carbon range C10 to C28) were not detected above their practical quantitation limit (PQL) of 10 milligrams per kilograms (mg/kg) in either sample. TPH in the extended (heavy oil) carbon range (C28-C40) was detected in the sample collected from Area B at a concentration of 1,090 mg/kg.

File : C:\HPCHEM\1\DATA\6080901.S\6080924.D  
Operator :  
Acquired : 10 Aug 2010 3:42 pm using AcqMethod TPHEXT.M  
Instrument : TPH  
Sample Name: 0608083-02@df4  
Misc Info :  
Vial Number: 2

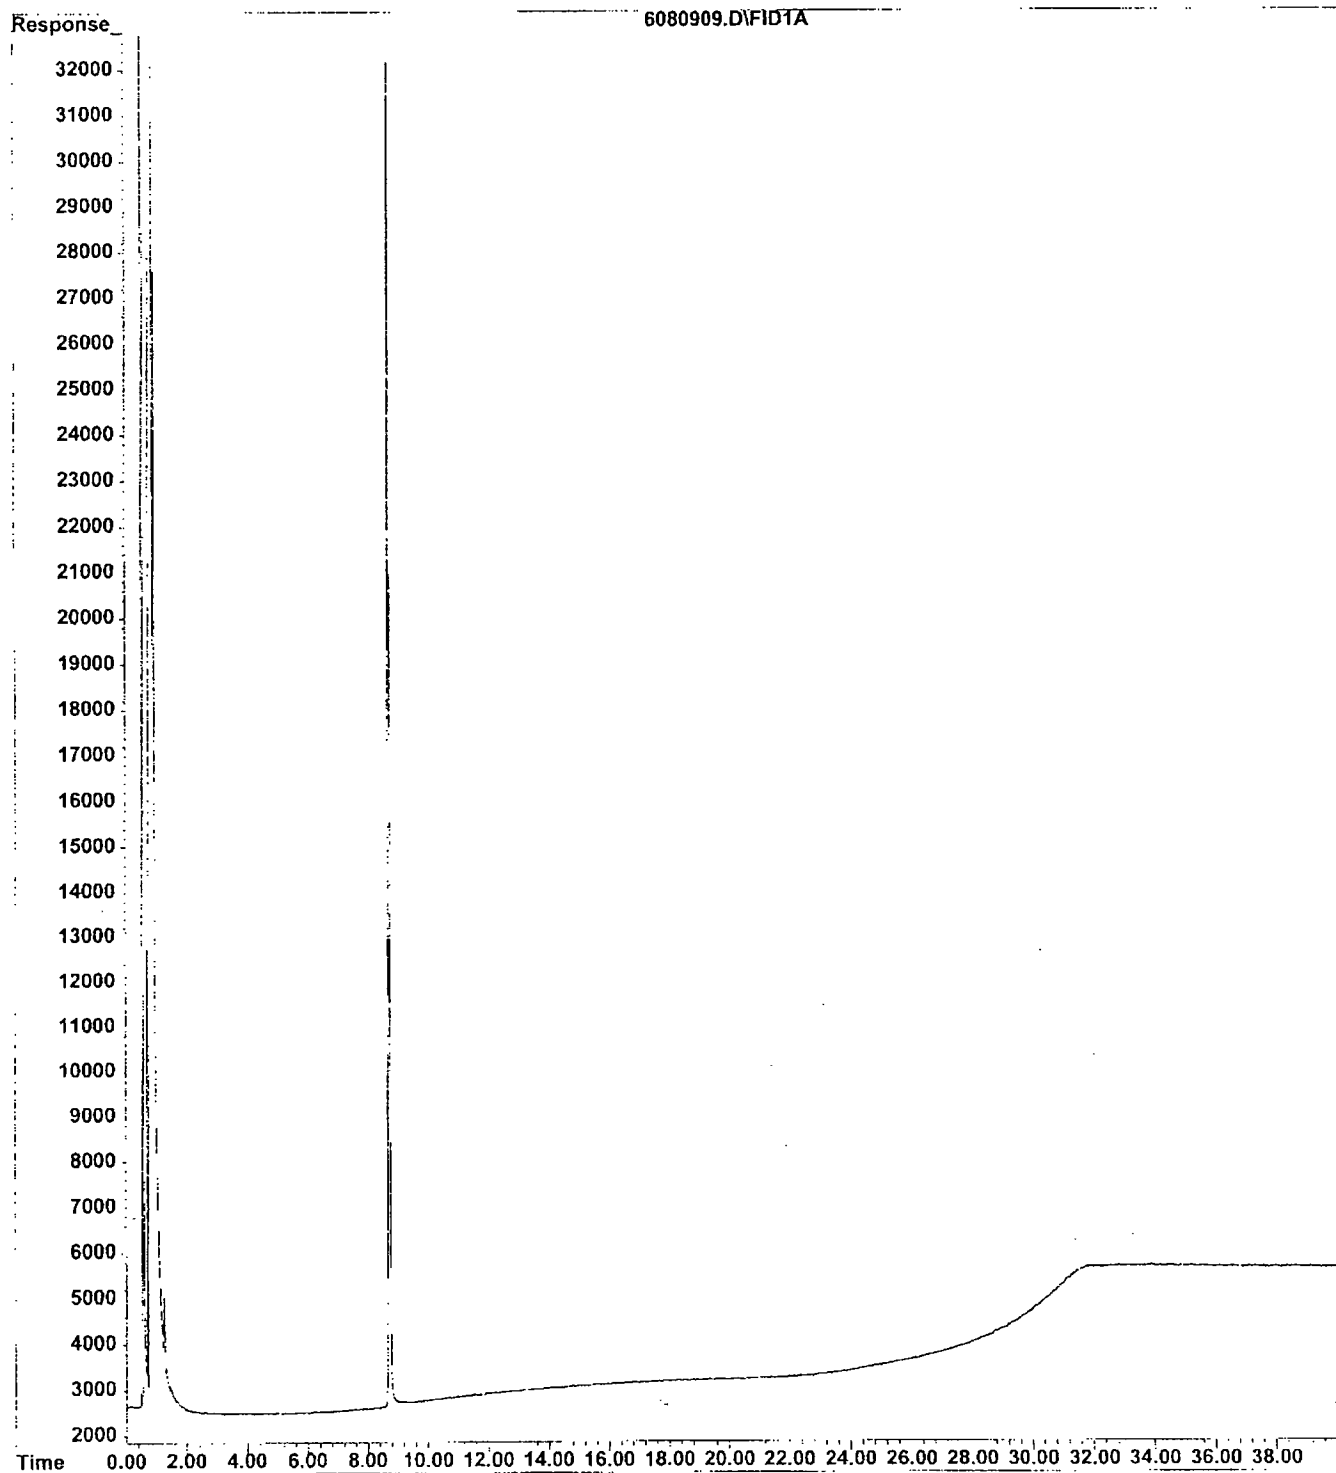
File : C:\HPCHEM\1\DATA\6080901.S\6080909.D  
Operator :  
Acquired : 9 Aug 20106 11:40 pm using AcqMethod TPHEXT.M  
Instrument : TPH  
Sample Name: 0608083-01  
Misc Info :  
Vial Number: 7
